# MARYLAND HISTORICAL TRUST NR-ELIGIBILITY REVIEW FORM

Offutt Farmstead (Thomas-Harwood House) (amended)

F-1-145

# Maryland Historical Trust Maryland Inventory of Historic Properties Form

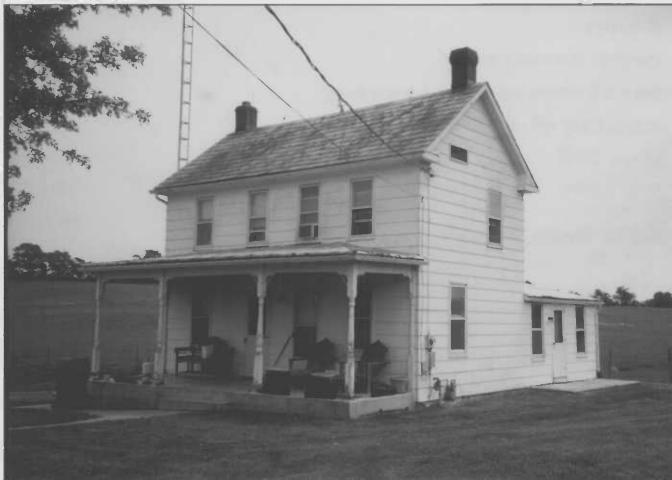
OFFUTT FARMSTEAD FREDERICK COUNTY, MARYLAND KATHERINE GRANDINE MAY 2001 MD SHIPO MAIN HOUSE, FRONT (N) AND W FACADES VIEW SE 1/10

The building's asymmetrical, four-bay front (north) facade features a full-width, one-story porch. The porch stands atop a poured-concrete foundation and features turned spindles with some jigsawn ornamentation. The hipped porch roof is sheathed in standing-seam metal roofing. The dwelling's two front (north) entrances contains a six-panel, wood doors.

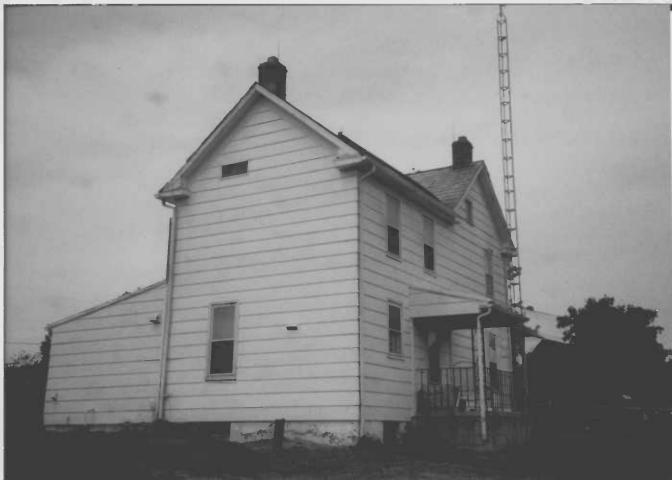
OFFUTT FARMSTEAD FREDERICK COUNTY MARYLAND KATHERINE GRANDINE MAY 2001 MC SHPO MAIN HOUSE, S AND E FACACES, UJEW NW 2/10

The three-bay east facade of the dwelling features a secondary entrance reached by a poured concrete stoop. A shed-roofed awning shelters the stoop, supported by a pair of recent metal supports. The awning is sheathed in corrugated metal roofing. The building's rear (south) facade measures two bays in width. The five-bay west facade features the building's third entrance, providing access to the infill addition. The entrance contains a five-panel wood door.

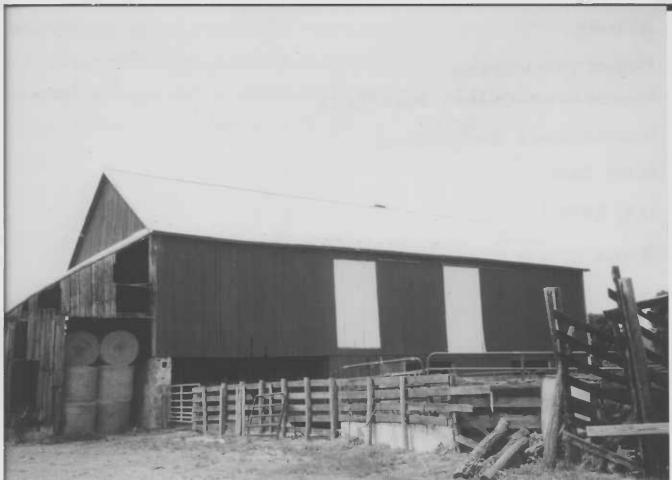
F-1-145 OFFUTT FARM STEAD FREDERICK COUNTY MARYLAND KATHERINE GRANDINE MAY 2001 MB SHIFE BANKBARN, S AND E FACADES, UTFU NU 3/10

<u>Barn</u>- A bank barn with wagon shed/corncrib extension is located northwest of the house. The standard barn rests on a stone foundation that closes the forebay on the south end. The barn is clad in flush vertical board siding on the east and west elevations.

The roof is corrugated metal. Board and batten siding is visible on the south end where the wagon shed/corncrib extension is appended to the barn. Sliding wood doors are located on the bank and the forebay elevations of the barn. The wagon shed/corncrib extension rests on poured concrete blocks and features a corrugated metal shed roof.

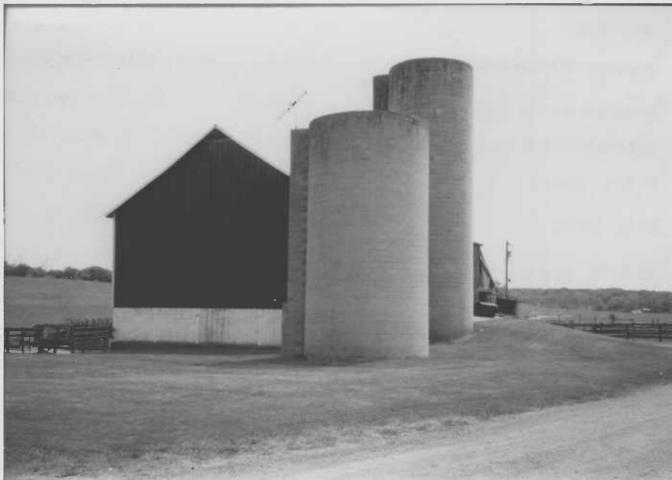
4/10

BANK BARN AND SILOS N FACADE, VIEWS

Two concrete-block silos are located near the north end of the barn. The silos have no roofs.

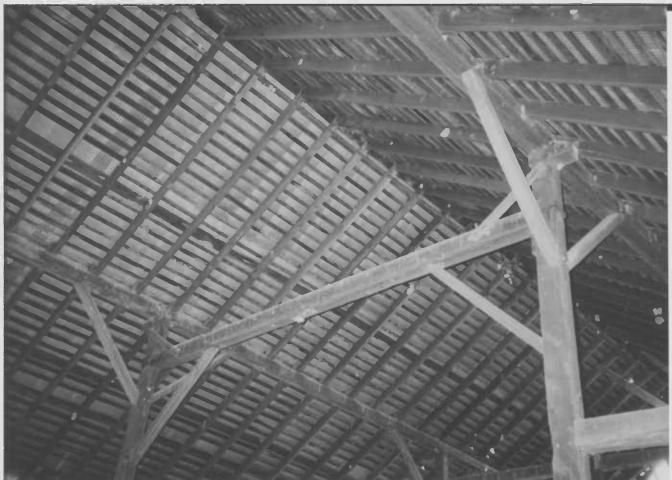
OFFUTT FARMSTEAD FREDERICK COUNTY, MARYLAND KATHERTALE GRANDINE MAY 2001 MD SHIPO BANK BARN INTERIOR 5/10

The interior H-bent framing system is constructed of oak and chestnut beams. Each bent comprises four upright posts that are supported by shorter tie beams mortised and tenoned into the upright posts across the width of the barn. The taller interior posts of each bent support the roof purlins. Angled struts from the uprights posts to the roof purlins provide additional support. A shorter tie beam is mortised and tenoned between these taller interior posts. The bents that define the hay mows feature a center upright post with a ladder. The roof rafters rest directly on the purlins and are lapped at the purlin. There is no center ridge pole in the barn.

Modifications to the barn include removal of original framing members and installation of new roof rafters. Originally pegged, most of the pegs have been replaced or strengthened with metal bolts. The north end of end of the barn has been entirely rebuilt with a concrete-block foundation wall and vertical metal siding; the rebuilding project occurred during ownership by the Offutt family. The new north end resulted in shortening the barn by one bay.

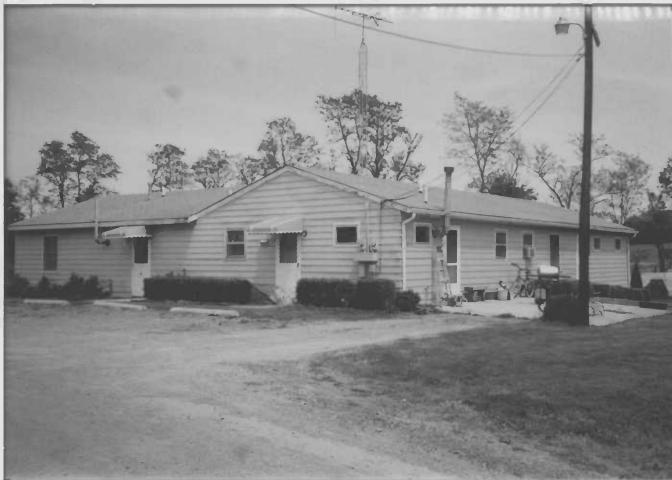
F-1-145 OFFUT FARMSTEAD FREDERIK COUNTY, WAR LAND KATHERINE GRANLINE MAY 2001 ME SHAO APARTMENT, FRONT (WEST) AND SOUTH FACADES, UZEW NE

<u>Apartments</u>- A former agricultural outbuilding has been redone into a rental property that contains two domestic units. The one-story, irregularly-shaped building is vinyl sided and features a completely renovated interior (Lynwood Offutt, Personal Communication 15 May 2001).

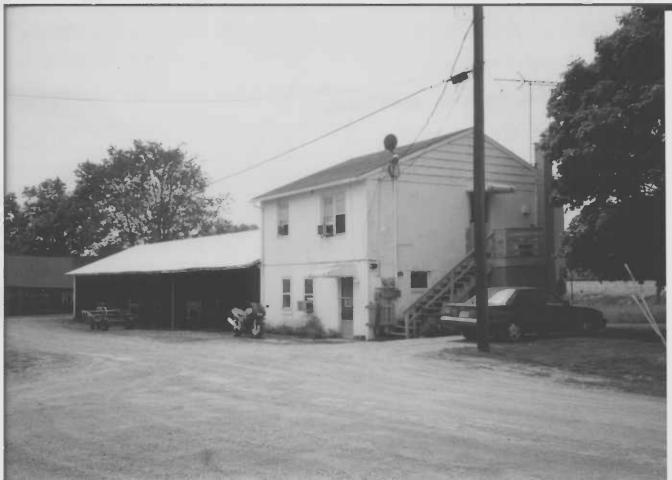
F-1-145 DEFUT FARMSTEAL FREDERICK COUNTY, MARYLAND KATHERINE GRANDINE MAY 2001 MD SHPO APARTMENT/SHED FRONT (F) AND N FACADES, UTEW SW 7/10

Concrete-Block Shed and Apartments (ca. 1970)- The two-story, concrete-block building occupies a site northwest of the house. The building stands on the south side of a farm road and faces east. The building consists of a two-story main block and a long, one-story shed and was built ca. 1970 (Linwood Offutt, Personal Communication 15 May 2001).

The building's asymmetrical, two-bay, north facade features a wood stair that provides access to the second-floor apartment. The second-floor entry occupies the center of the facade and features a metal hood. The building's single brick exterior chimney stands off-center on the north facade. The north wall below the gable features horizontal wood siding. The rear (south) facade of the building's main block measures two bays in width. The building's interior was completely rebuilt in 1982 (Linwood Offutt, Personal Communication 15 May 2001).

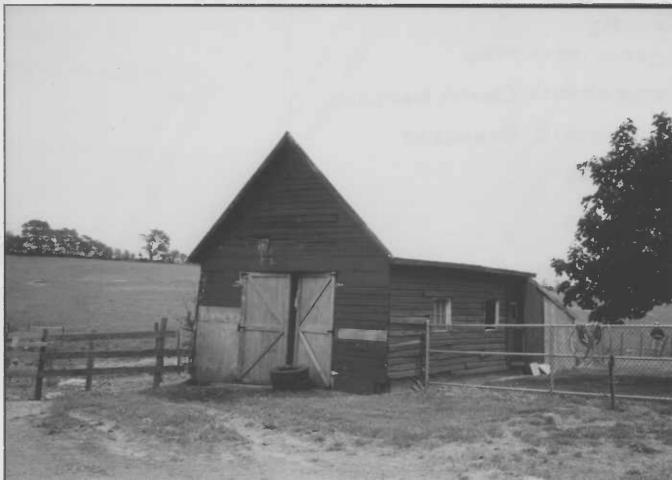
OFFIT FARMSTEAD FREDERICK COUNTY MARKANS KATHERINE GRANCINE W47 5001 ML SHPO GARAGE, FROM CNOPAL IN FACADES VIEW SE 8/10

Garage- The one-story, utilitarian frame garage stands northeast of the main house. The front-gabled building faces west. The garage adopts a rectangular footprint atop a concrete-block foundation. The walls of the building are composed of simple drop siding. Window openings contain six-light, fixed windows. The garage's moderately-pitched roof is clad in corrugated metal. The building has no chimney. Appended to the rear (south) facade of the building is a corrugated-metal shed addition.

The symmetrical front (north) facade of the garage features a recent plywood double door. The asymmetrically-fenestrated west facade features two window openings and a door opening. The door opening contains a four-light-over-three-panel wood door. The single-cell interior of the building is unfinished. The shed has a poured-concrete floor.

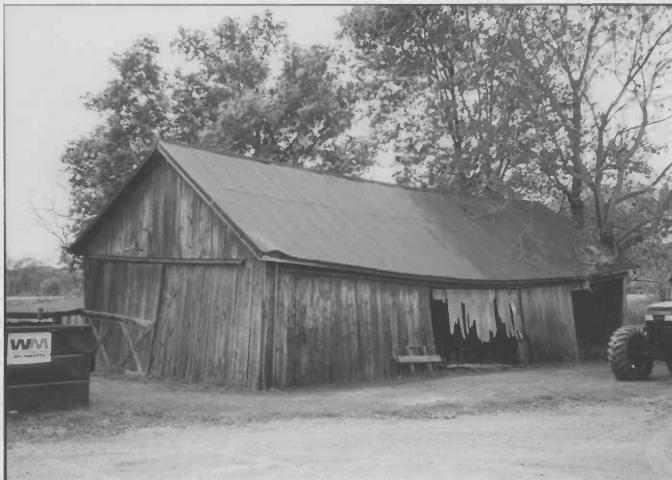
F-1-145 OFFUTT FARMSTEAD FREDERICK COUNTY, MARYLAND THATHERINE GRANDINE 1005 PAM MB SHPO SHED, FRONT (E) AND N FACACIS VIEW SW

<u>Shed</u>- The one-story, balloon-frame shed stands northwest of the main house. The front-gabled building faces east and occupies a rectangular footprint. The building's frame rests directly on the ground. The building is clad in flush, vertical board siding. The building's moderately-pitched roof is sheathed in corrugated metal. The shed is in decrepit condition.

The front (east) facade of the shed features a sliding-track door composed of vertical boards. Two similar sliding-track doors appear on the building's north facade. The shed features no other openings. The single-cell interior of the shed is unfinished.

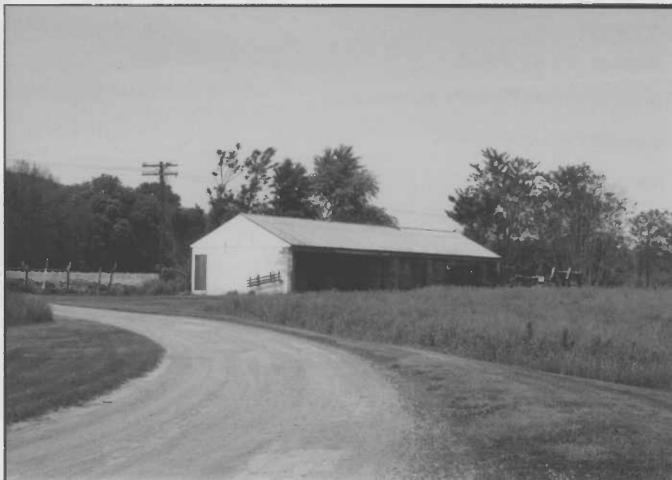
F-1-145 OFFUT FARMSTEAD FREDERICK COUNTY MARYLAND KATHERINE GRANDINE MAY 2001 MD SHPO HAY SHED S AND FRONT (E) FACADES, UTEU NIW 10/10

Other Outbuildings - Other outbuildings include a one-story, concrete-block shed with a corrugated-metal, gabled roof. The building originally was a farrier barn, but now is used for hay storage. The east side of the building is open. A second hay storage building is a

one-story, metal-frame and metal-clad building. A one-story, shed-roofed equipment shed and animal pen clad with vertical board siding is of recent construction.

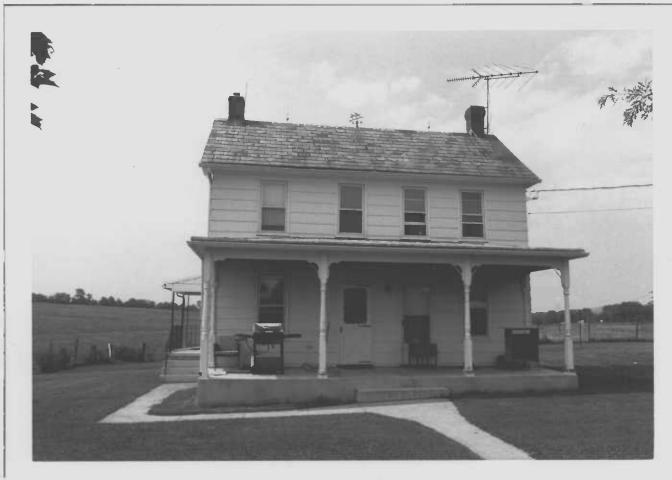
1 =1= 145 Thomas-Forwood Farms-600 Frederick County Photos Jonet Douis Nea. loc. : Md. SHIPO Procensuille Md. North elevation

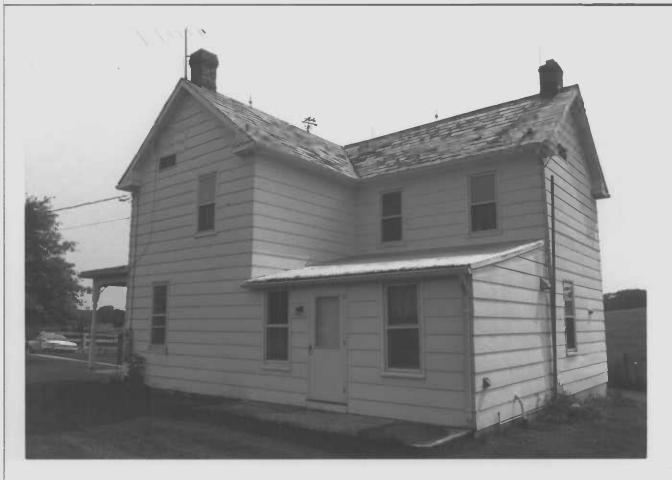
--1-145 Thomas - Horwood Farmstead Frederick County Photo: Janet Davis JUNE 1993 1) ear loc in Md IHPO Crownsville Md. Southwest corner wew 2/3

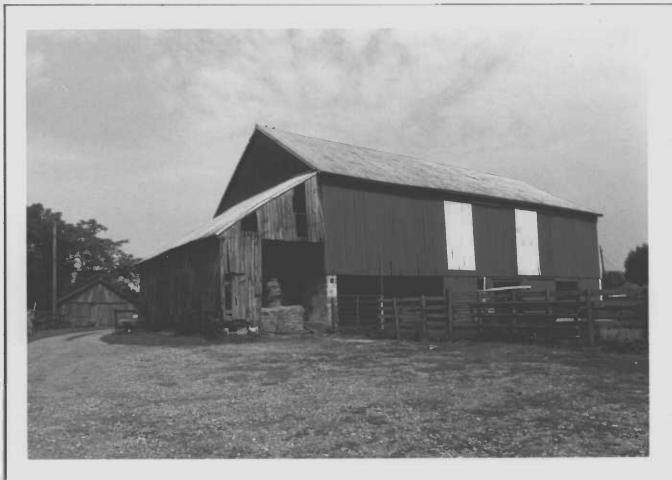
F-1-145 Thomas - Horwood Formstead Frederick County Photo: Jonet Davis June 1993 Neg. loc .: Md SHTO Crownsville Md. Bank born, east elevation

Bank barn: The frame bank barn located north of the house has vertical siding and a corrugated metal roof. On the south gable end of the barn is a wagon shed addition with a corn crib on the outer side. The stall level on the east elevation is partially enclosed by wood partition walls. Next to the ramp on the west side of the barn is a non-contributing concrete silo. The barn appears to date from about 1875-1900, although its interior was not accessible for examination of the interior framing structure.

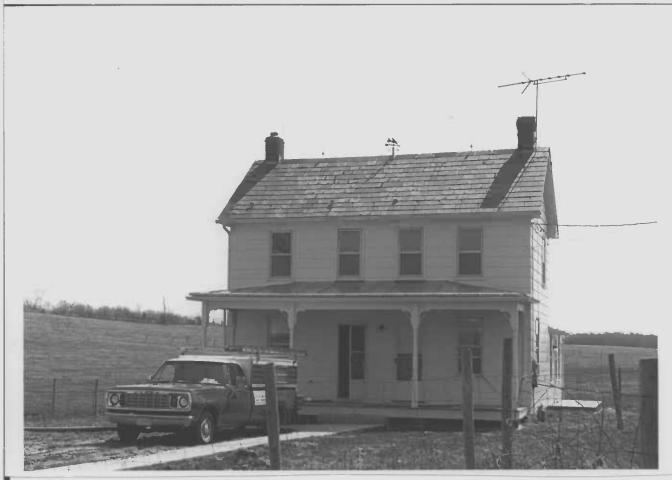
F-1-145 Thomas/Glenwood House North elevation Peggy Bruns Weissman June 1982
